Appendix D—Case Studies

Lake Valhalla Project Plan

Henry M. Jackson Wilderness, Wenatchee National Forest, WA.

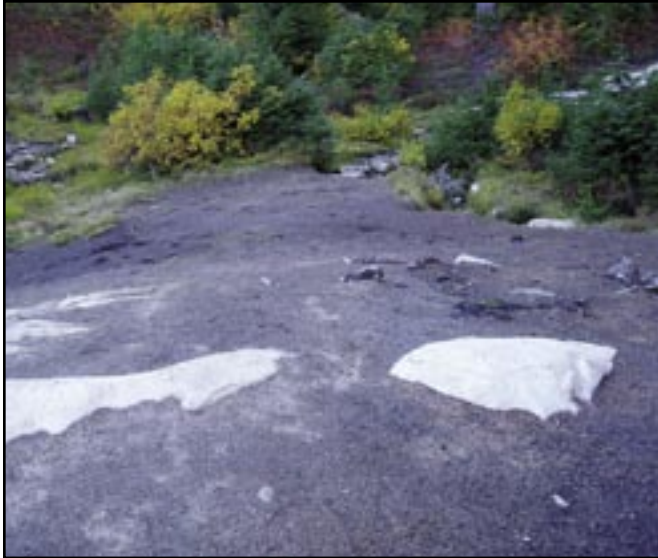
Figure D-2—Fragile sites, such as this campsite at Lake Valhalla, are easily degraded.

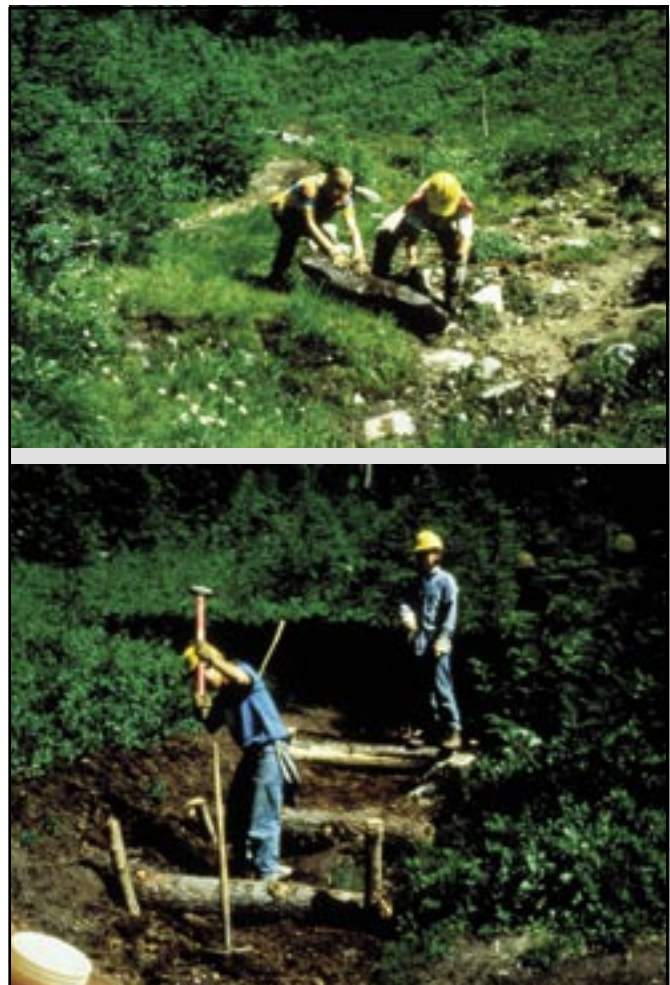
Figures D-3a and 3b—Teenagers on a Student Conservation Association high school work crew spent many hours installing and backfilling rock (top) and installing log checkdams (bottom) to stabilize erosion at Lake Valhalla.

This project was implemented largely as described in 1992. A Student Conservation Association high school work crew (figures D-3a and 3b) completed the initial trail work, as well as campsite and trail closures. All fill was collected and hauled locally without the use of a helicopter. A fall

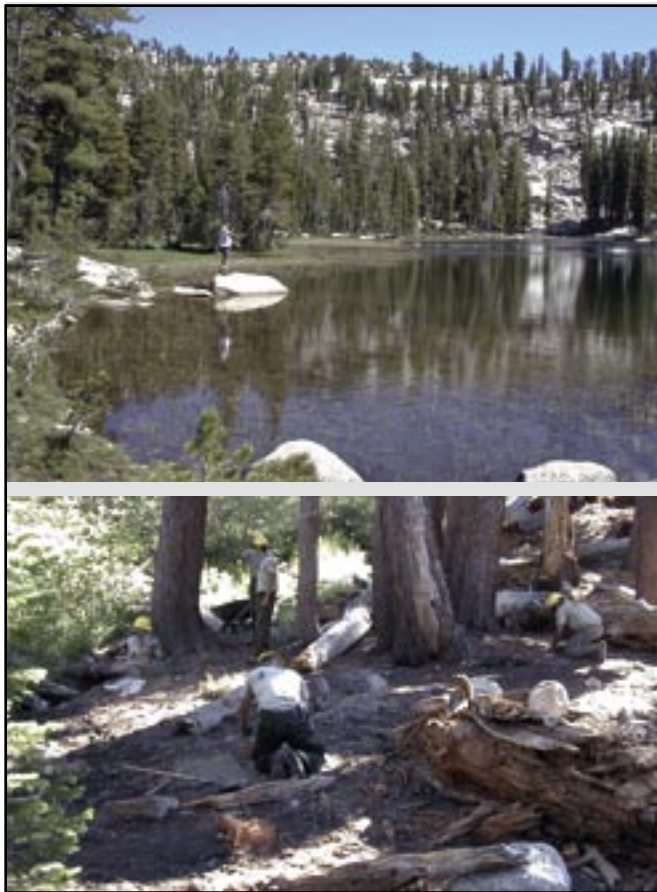
Figures D-4a and 4b—Ease of access to Grouse and Hemlock Lakes (top) in the Desolation Wilderness, CA, led to extensive impacts (bottom).

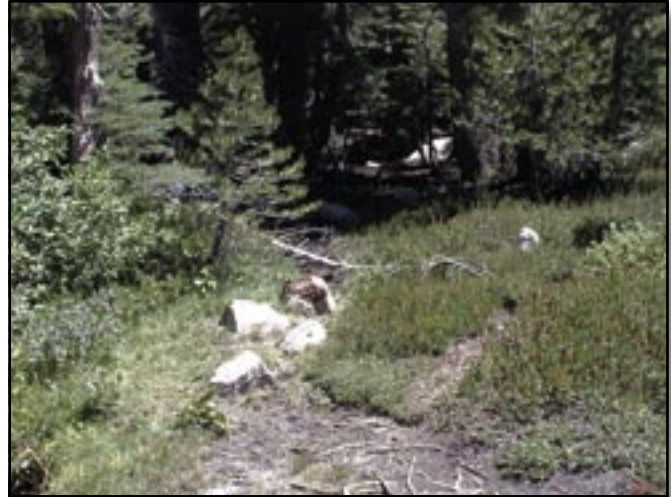
Figure D-5—Rocks and logs were installed on social trails and closed campsites to deter use and provide microhabitat for plantings.

- Established designated campsites within 500 feet (152 meters) of Grouse and Hemlock Lakes.
- Restored eliminated campsites and social trails to natural conditions. Restoration activities involved revegetating the area by breaking up compacted soil, mulching with native materials, transplanting native plants found onsite, and placing rocks and logs to give the area a natural appearance and to encourage groups to use the well-established, durable sites and avoid the sensitive areas (figure D-5).

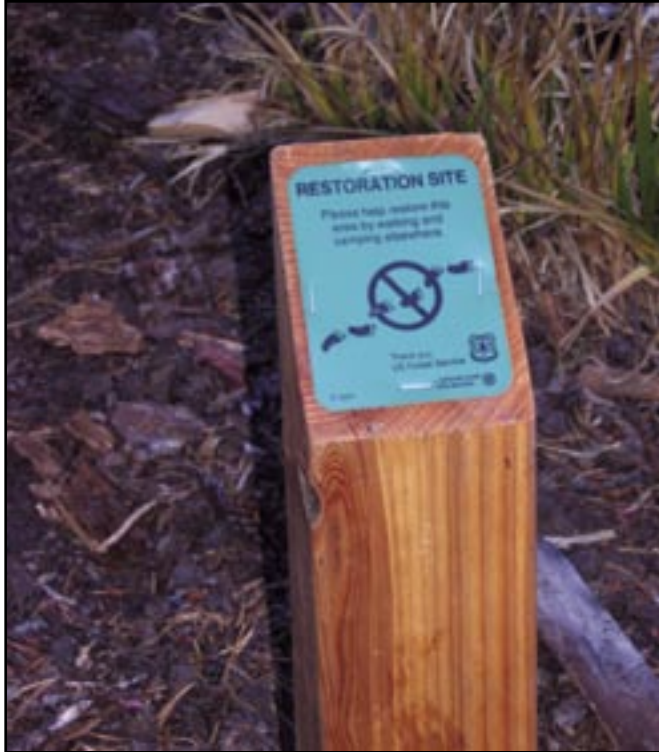
Figure D-6—Restoration closure signs helped deter use at closed sites.

- Temporary signs are in place at selected restoration sites where it was difficult to discourage visitor use through engineering. The signs are on a 4- by 4-inch (about 100- by 100-millimeter) wooden post: "Restoration Site: Please help restore this area by walking and camping elsewhere." (figure D-6).

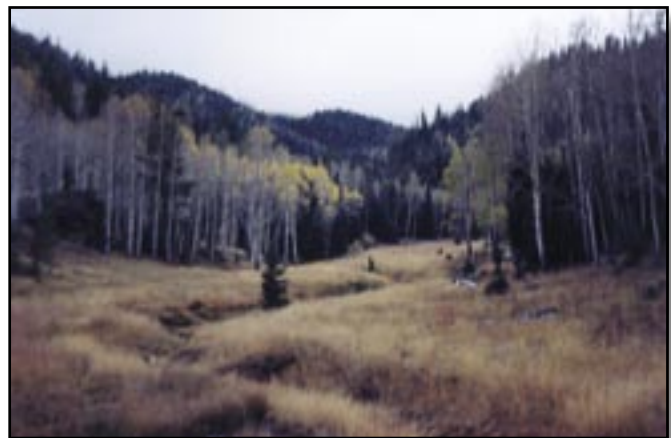
Figure D-7—Mill Flats had substantial changes in vegetative composition because of overgrazing. Restoration involved improving management of grazing. No active revegetation was needed.

cattle have overgrazed the area, leaving stunted and severely damaged forage plants and forbs. Much of the area is denuded of plants, which has led to gullying and erosion in the riparian areas. Cows like to wallow and root with their heads in the soft earth of the gully banks, enlarging the gullies.

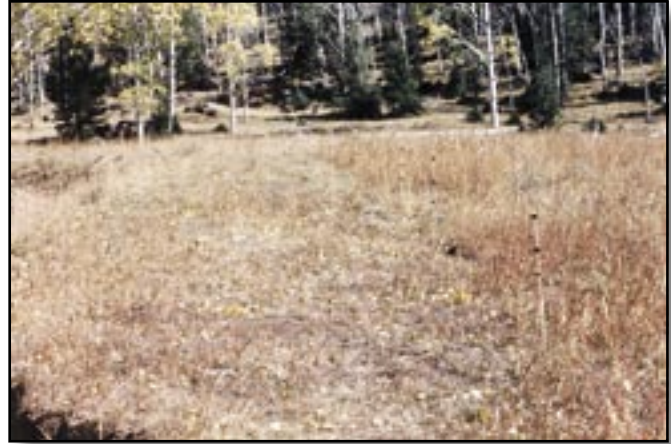
Figure D–8—Commercial livestock were rotated between three pastures separated by electric fences.

We have experienced fairly good success with the electric fence, although at first we did have some vandalism and some visitors let the fence down so their stock could graze inside. It took some time to change the attitude of some visitors and ranchers so they could accept the fence and the idea that the fence was going to stay. I think persistence and patience on our part have been the reasons for their change of attitude. We also have tried to explain the project’s goals to visitors. In the past few years, folks have begun to accept and support the project.

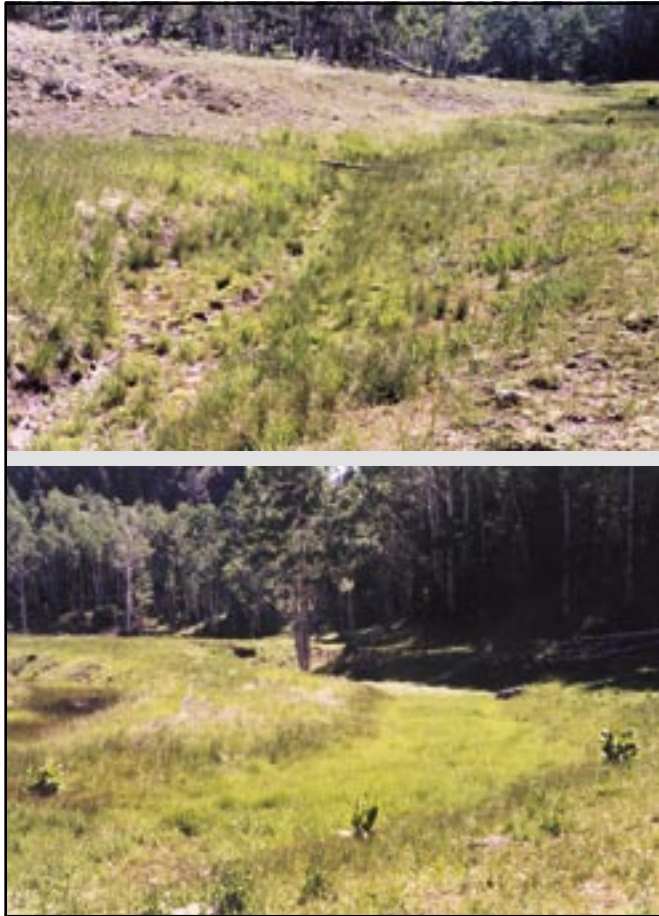
Figures D-9a and 9b—These before (top) and after (bottom) photos show the response of vegetation after grazing pressure was reduced at Mill Flats.

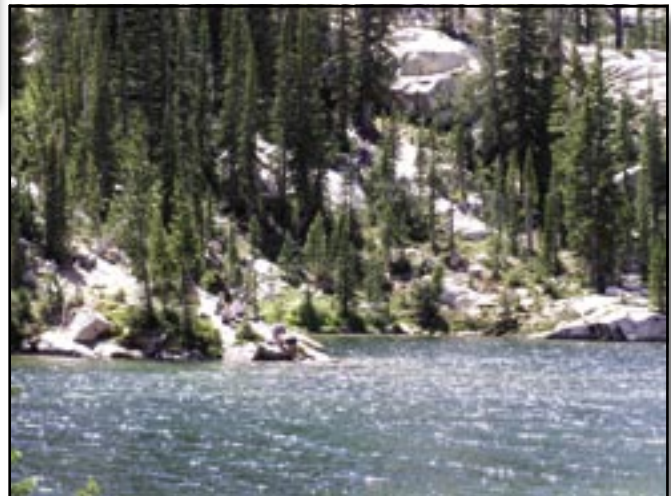
Edith Lake (figure D-10) was formed by glaciation. The lake sits in a small cirque basin formed in the Idaho batholith at about 8,660 feet (2,640 meters) in the subalpine zone of the Sawtooth Mountains of south-central Idaho. The dominant tree species include lodgepole pine and subalpine fir. Grouse whortleberry is dominant in the understory. Slopes are steep, vegetation is sparse, and soils in this area are predominantly shallow, silty pockets along shorelines or among granitic outcrops. Temperatures are extreme, the growing season is short, and moisture comes predominantly in the form of snow.

Figure D-10—Edith Lake in the Sawtooth Wilderness, WA.

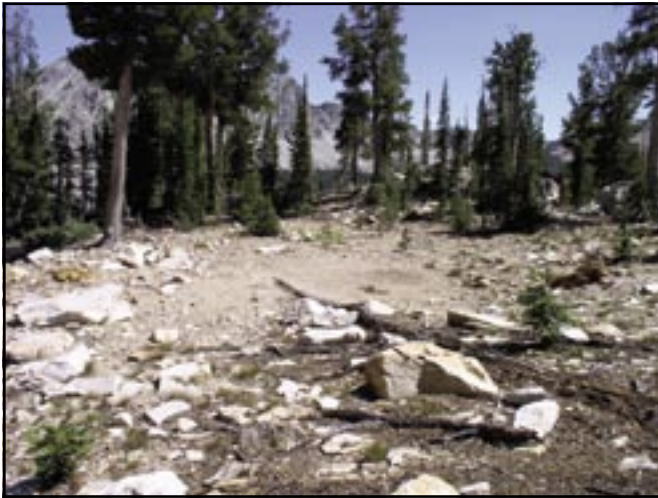
Figure D-11—This campsite was opened after five others in less suitable areas were closed and rehabilitated.

- An alternate site (figure D–11), suitable for large groups, was found and a user trail was

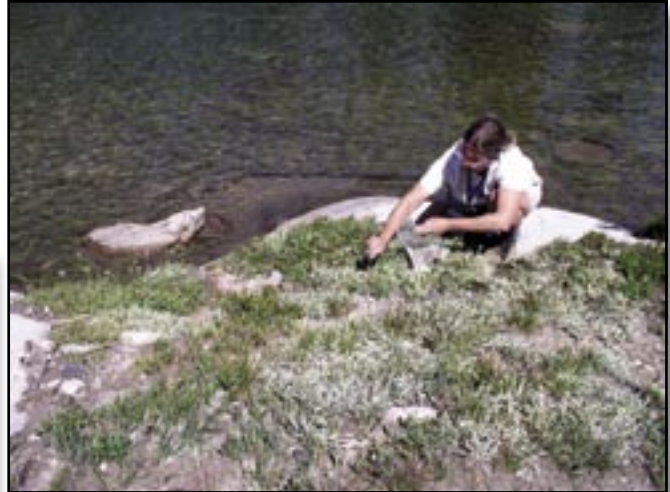
Figure D-12—Gathering seed used to restore vegetation at closed campsites.

- During the summer of 2003, the changes were explained to front desk personnel so they could help visitors locate the preferred group site and understand how they could help the rehabilitation. “Closed to Camping” signs were placed at this site. Another small sign was placed at the junction of the maintained trail and the trail that directed users to the new site for large groups.
- During the late summer of 2003, more local seed was gathered (figure D-12). Our timing was better this year and seeds had not dispersed. The seeds were mixed with mud and manure from the site and formed into small balls that were scattered at the sites.

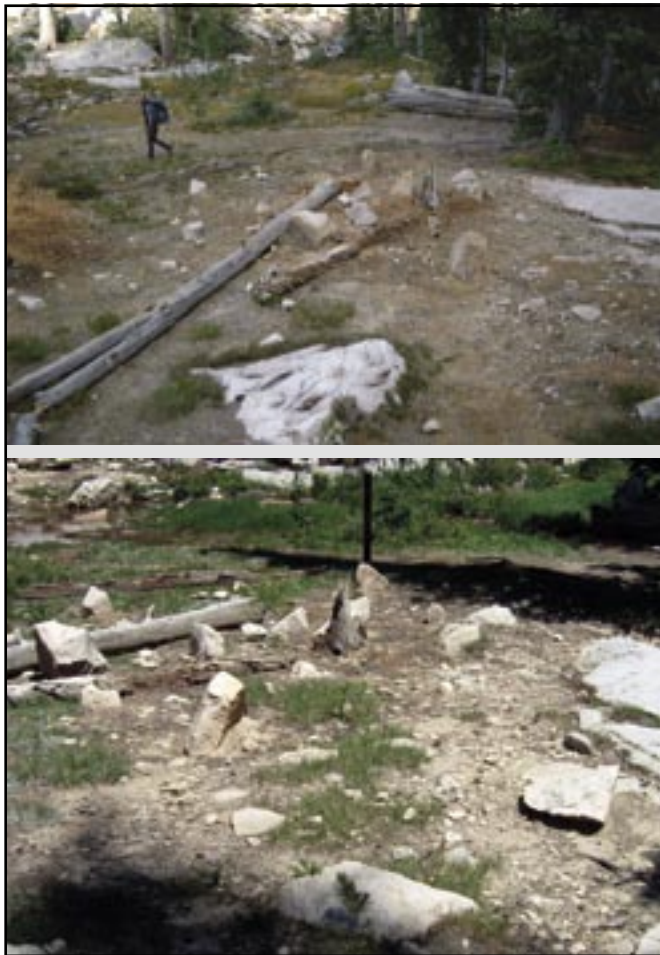
Figures D–13a and 13b—This heavily impacted campsite (top) at Edith Lake has begun to recover (bottom).

Monitoring was conducted through wilderness ranger observations, campsite condition inventories, and photo documentation. Overall, I would consider the project a success. However, the degree of success varied across sites—two of the sites were only partially restored, leaving a portion of the sites for day use by stock and for access to the lake. These two sites have been the least successful. At one of the sites, no plants have grown, but the iceberg rocks are still in place. Recent observations determined that fires have been built, despite a no-campfire regulation that is in effect. The other site allows access to the lake and, despite signs, it appears that camping is continuing. Some of the debris has been removed and there is little regrowth at the site. The remaining three sites have multiple seedlings, and some sedges and grasses are reestablishing themselves (figures D-13a and 13b). All but one of the transplanted saplings survived and appear to be growing.

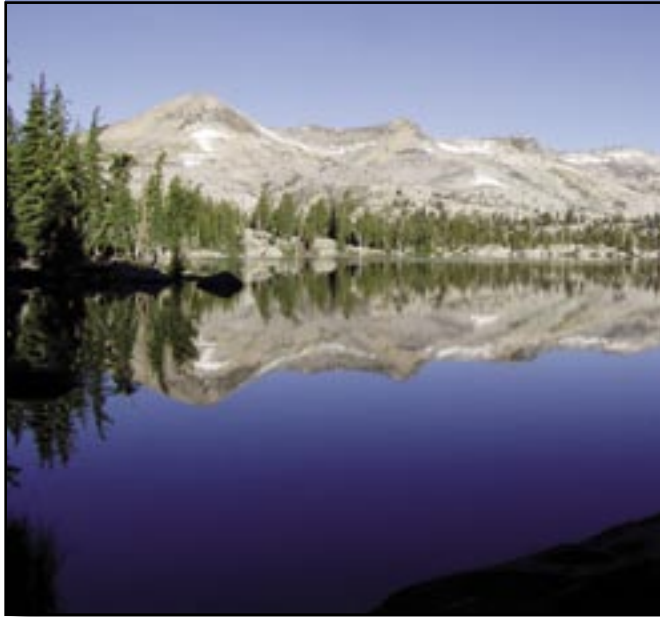
Lake of the Woods (figure D–14) is in the subalpine zone, at about 8,000 feet elevation in the Crystal Range of California’s Sierra Nevada Mountains. Lake of the Woods is one of the larger lakes within the Desolation Wilderness. The lake basin is densely forested with lodgepole pine, mountain hemlock, and red fir. The area surrounding this lake basin consists mostly of granitic soils with sparse vegetation and steep terrain.

Figure D-14—Lake of the Woods in the Desolation Wilderness, CA.

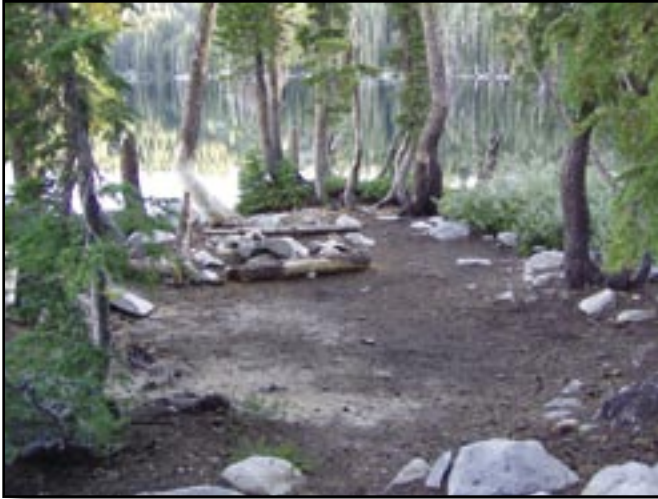
Figure D-15a—Campsites that had the highest impacts were the first to be restored.

- Campsites in undesirable locations were restored to natural conditions. The campsites that had the highest impacts were the first to be restored. Restoration activities involved breaking up compacted soil, placing rocks and logs to give the area a natural appearance, and mulching the surface with native materials (figures D-15a and 15b).

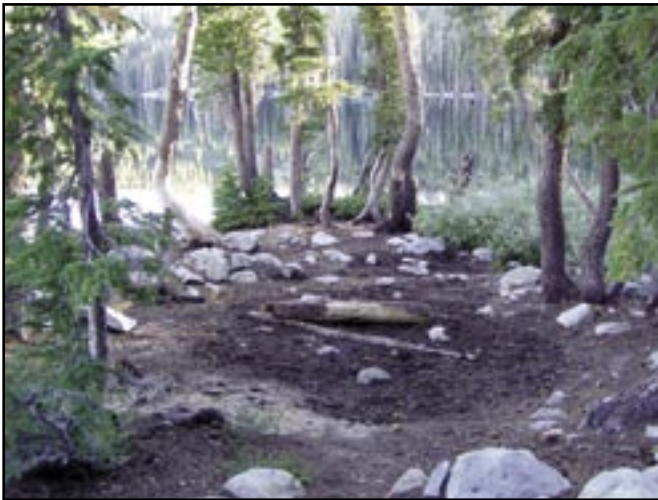
Figure D-15b—Campsites in undesirable locations were restored to natural conditions.

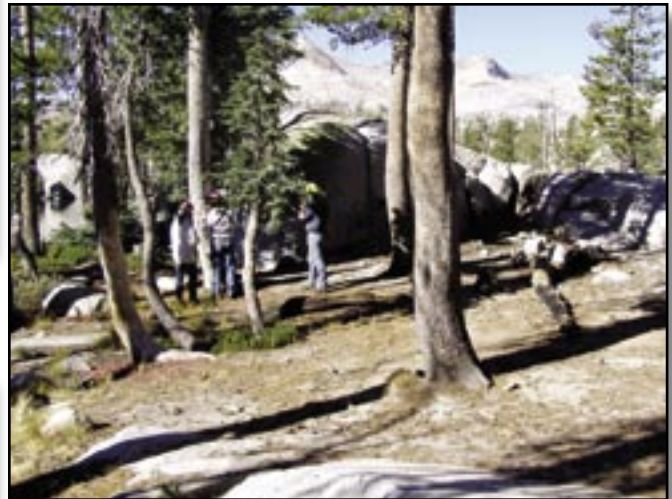
Figure D-16a—Several campsites merged into one large campsite. Rocks and logs to restore the site's natural appearance were in short supply.

merged into one large campsite) and rocks and logs to restore the site's natural appearance were in short supply, snags were directionally felled by blasting to provide some ground cover and discourage use (figures D-16a and 16b).

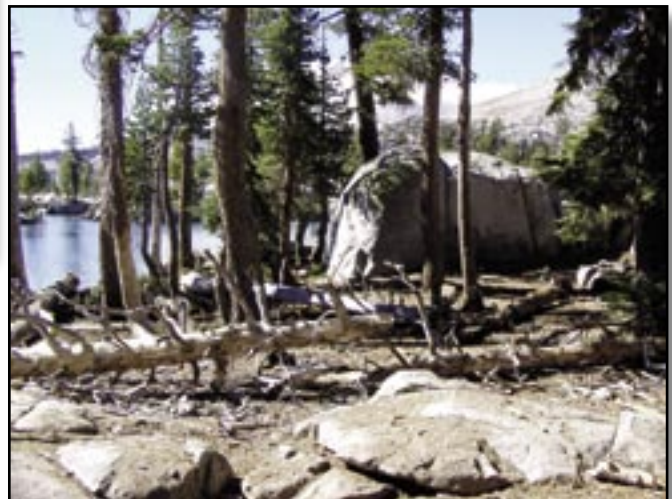
Figure D-16b—Snags were directionally felled by blasting to provide some ground cover and discourage use.

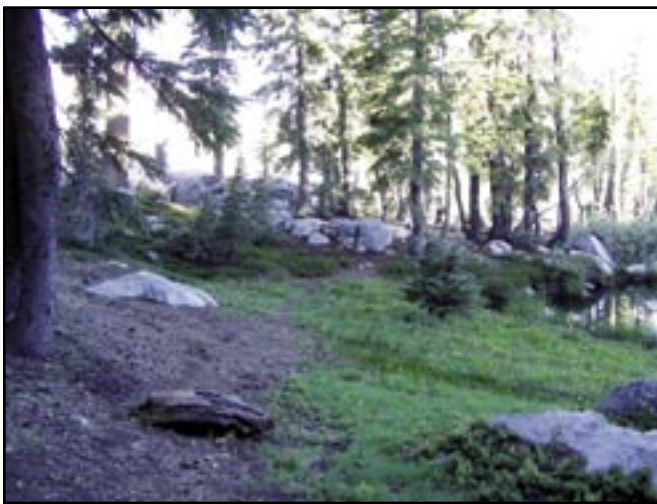
Figure D–17a—Access trails leading to campsites in undesirable locations also need to be closed.

- After the blasting project removed the hazard trees, nine campsites were designated.
- Temporary signs were installed where it would have been difficult to use rocks and logs to keep visitors from trampling the restoration site (figures D–17a and 17b).

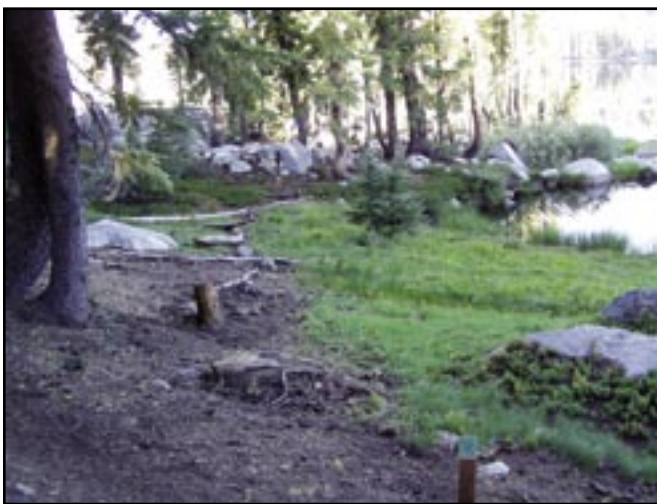
Figure D–17b—Temporary signs were installed at access trails and campsites to keep visitors from trampling the restoration site.

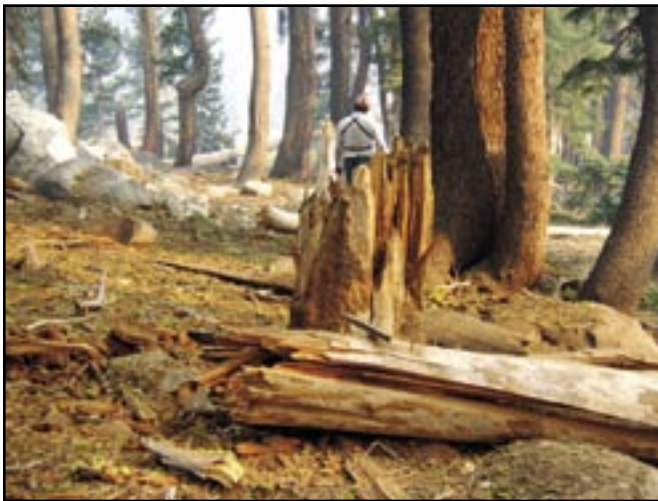
Figure D–18a—This stump appears to have been broken off naturally, helping to maintain the wilderness character.

Relying on blasting rather than using crosscut saws to fell snags allowed the natural wilderness character to be maintained. If the trees had been felled with crosscut saws, saw marks would have been left on the trees. Motorized equipment was not considered.

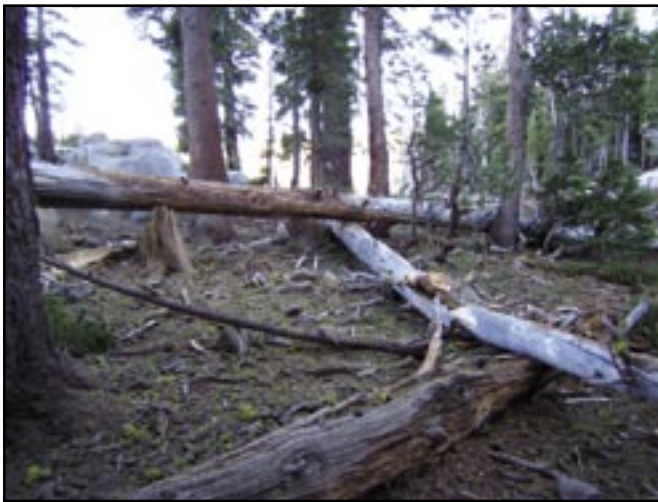
Figure D–18b—After blasting was complete, the campsite had a natural appearance and the fallen logs discouraged camping on the restored site.

areas, so snags were blasted as a restoration technique (figures D–18a and 18b).

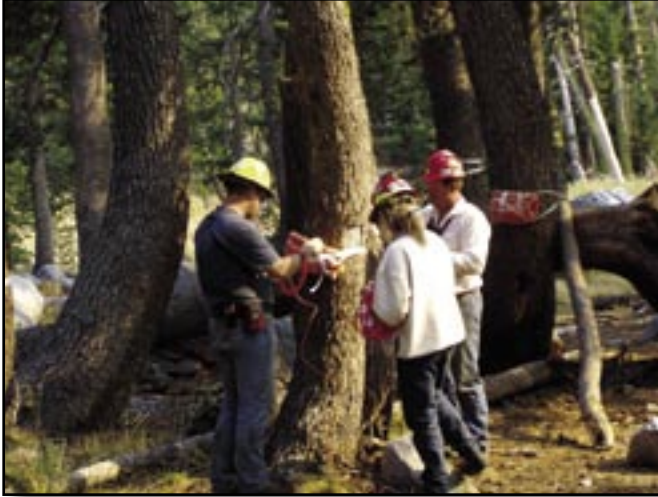
Figure D-19—Strapping explosives to trees.

- Blasting trees (figure D–19) was an extremely effective restoration method, particularly in areas where rocks and fallen logs were not readily available. This technique was especially helpful at larger campsite areas where it would have been difficult to discourage visitor use otherwise. This technique produced immediate results.

- Not only did blasting provide fallen logs, it also provided mulch materials (tree bark, needles, branches) for ground cover.
- Blasting maintained the wilderness character, leaving a natural appearance rather than saw marks on smooth stumps and the ends of logs.
