**RESTORATION, BARRICADES, AND SIGNAGE**

# Detering ORV Use & Lessening Its Impacts

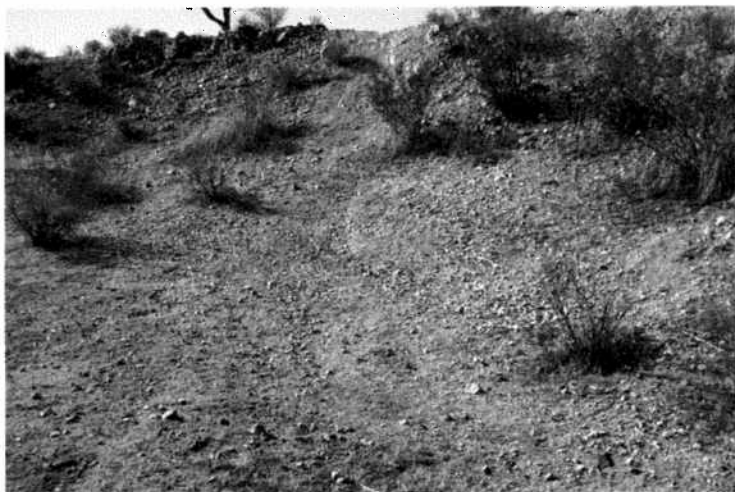
Unauthorized Vehicle Trail before Restoration

Today, the techniques in use by SCA crews are geared towards blending illegal routes in with the surrounding landscape, while, at the same time, encouraging regrowth. The most common of these techniques is called vertical mulch, whereby dead shrubs or creosote branches are gathered and replanted on illegal routes to look like real, dead bushes. Typically, seed pits are then placed at the base of the mulch, providing a convenient microclimate for new plants to grow.

Some other commonly used restoration techniques include horizontal mulch (laying dead plant matter, such as Joshua tree logs, across incursions), raking and sweeping to remove any visible vehicle tracks, adding rocks from the surrounding landscape, and decompacting soil. When done well, these techniques can trick even a discerning eye into believing that the incursion they are hiding was never there at all.

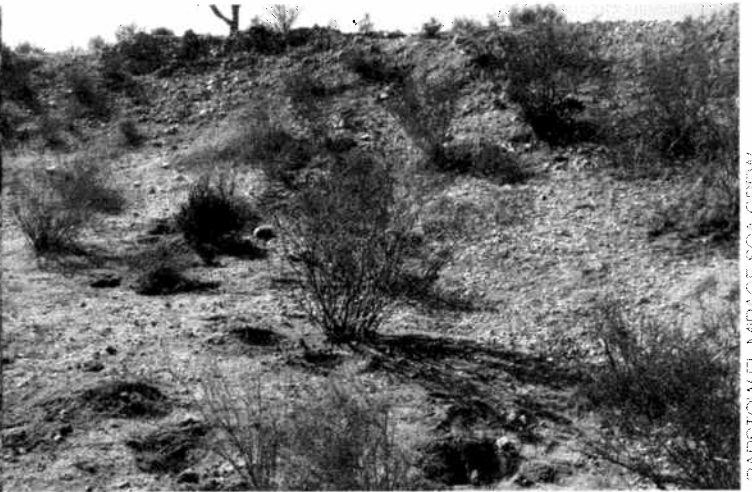
Identical Trail after Restoration
