**TRAILS DESIGNATION PROJECT IMPLEMENTATION - PHASE ONE
ACCOMPLISHMENT REPORT**

**SHAWNEE NATIONAL FOREST
HIDDEN SPRINGS RANGER DISTRICT
FISCAL YEAR 2006**

**Trails Designation Project Implementation – Phase One
Accomplishment Report
Hidden Springs Ranger District
Fiscal Year 2006**

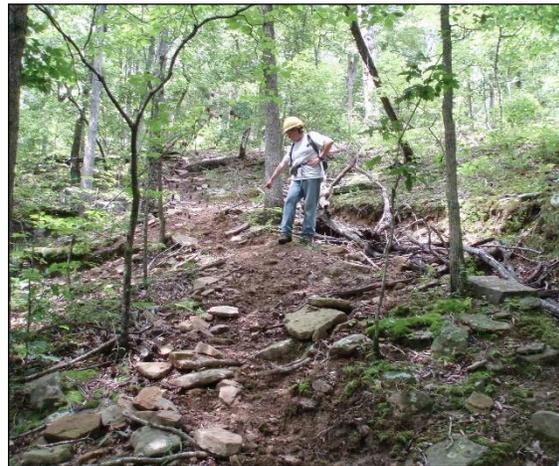
Figure 2. Forest Volunteer monitoring previous eroded sections of Goat Trail.

Trails Designation Project Implementation: The 2006 trail project season saw the implementation of the much awaited Trails Designation Project on the Shawnee National Forest. The Trails Designation Project involves designating, constructing and maintaining a 223-mile trail system within four watersheds. The four watersheds (Eagle Creek, Big Grand Pierre Creek, Lusk Creek, and Upper Bay Creek) are located in southern Illinois and comprise about 30 percent of the Forest. An important aspect of this project is wilderness management relative to equestrian use (Figure 1). This season, the Trails Designation Project focused on constructing new sections of trail re-routes for hiker and equestrian use throughout the Lusk Creek Wilderness. Newly designated re-routes were constructed to improve trail and resource conditions. For instance, previously eroded sections of Goat Trail fell straight down the canyon (Figure 2). The newly re-routed sections now follow the natural contour and proper grade (Figures 3 and 4).

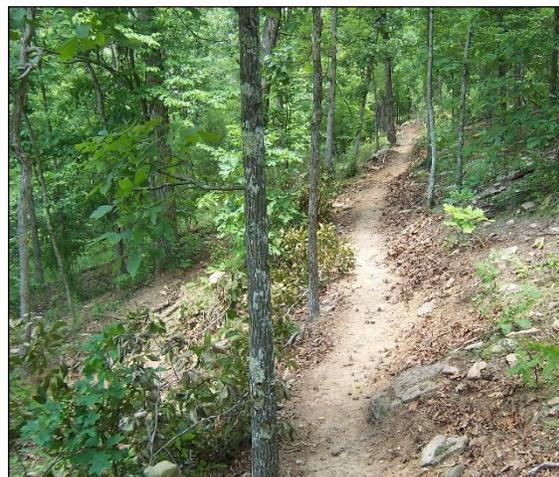
Figure 4. Newly re-routed section of Goat Trail following the natural contour.

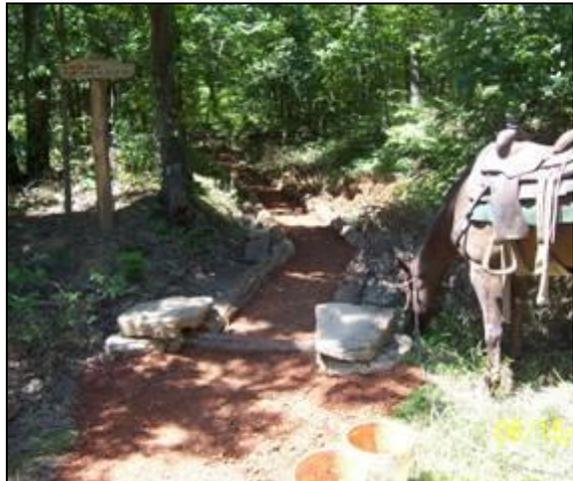
Figure 8. Newly reconstructed and signed northern entrance to Secret Canyon at Lusk Creek Wilderness.

Trail Work in the Wilderness: In accordance with the Wilderness Act of 1964 and the Illinois Wilderness Act of 1990, trail work in the wilderness was accomplished using only primitive tools and traditional methods. To accomplish this task, the Hidden Springs Ranger District hired a seasonal trail crew comprised of eleven local college students, a crew leader, and a trails technician (Figure 5). The crew members worked ten hours a day five days a week for three months using only hand tools to construct trails in the Lusk Creek wilderness (Figure 6). Tools, equipment, and building materials were carried by hand or pack stock over rough terrain in order to reach the project sites (Figure 7). In less than three months since the implementation of the project on June 24, 2006, the trail crew, with over 6,000 person-hours invested on the ground, made significant accomplishments on trail work within the wilderness (Figure 8).

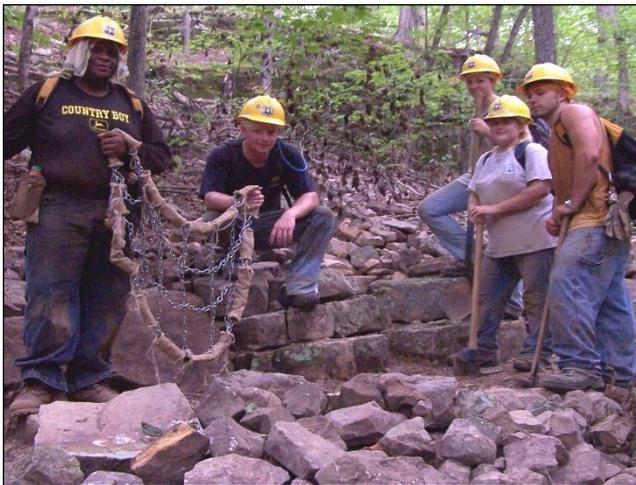
Figure 13. Trail crew members standing next to stone retaining wall with fabricated rock basket.

Figure 8. Traditional Methods: Detailed rock work accomplished by the trail crew is comparable to that of the high quality trail work accomplished by the Civilian Conservation Corps in the 1930's that continues to stand as a testament to hard work, ingenuity, and taking pride in accomplishment (Figure 13). The trail crew, under the direction of Trails Technician Brian Bourne, resurrected the art of dry stack masonry, using stone without mortar, in building many trail features (Figures 14 - 16). This traditional method has been nearly lost or abandoned for modern means. Cribbed retaining walls used this method and were one of numerous structures built in order to implement sustainable trails on steep side slope. Ten tons of sandstone rock was used for the retaining wall along the re-route north of secret Canyon (Figure 17). Natural building materials such as sandstone were also used to construct intricate trail features such as rock walls, stairs, and climbing turns that often descended into and climbed out of canyons (Figures 18 - 20). A switchback, with French drain, required 2 tons of gravel crushed with a sledge hammer (Figures 21 and 22).

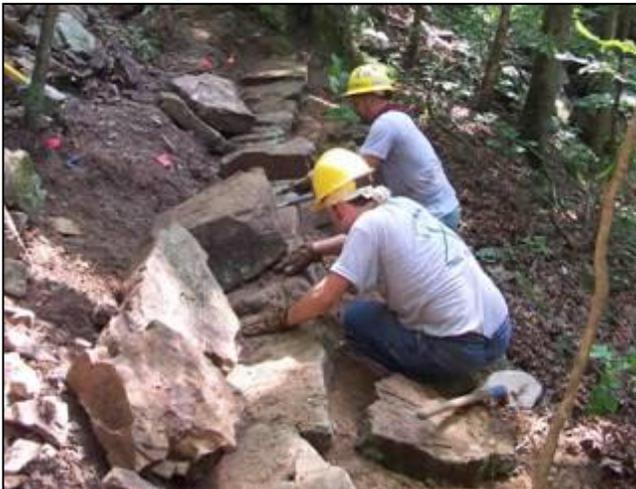
Figure 15. Dry stack masonry being used to construct a retaining wall.

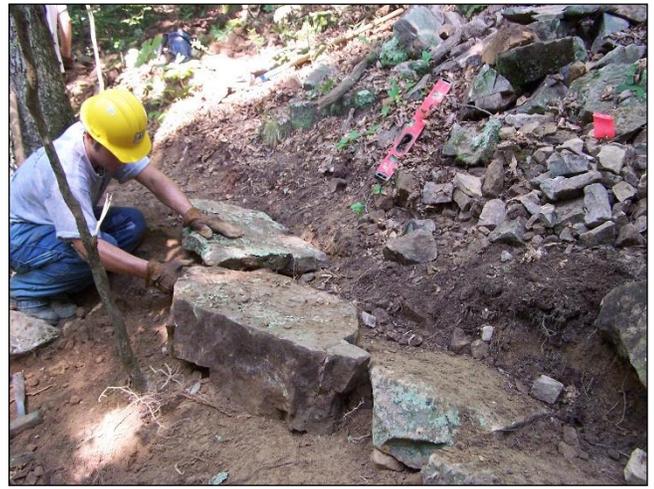
Figure 16. Dry stack masonry being used along the trail.

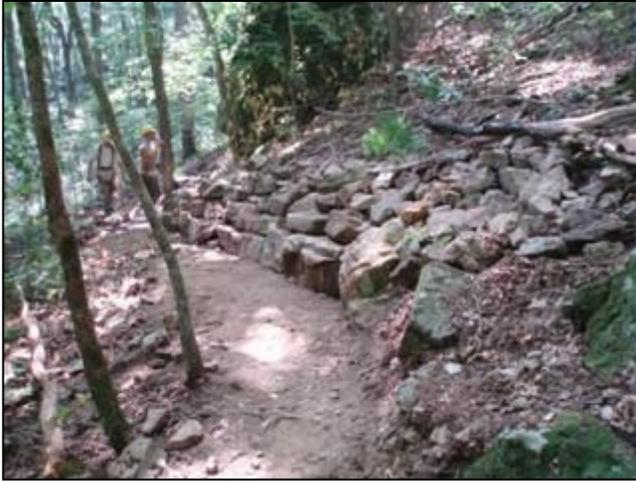
Figure 17. Cribbed retaining walls built in order to implement sustainable trails on steep side slope.

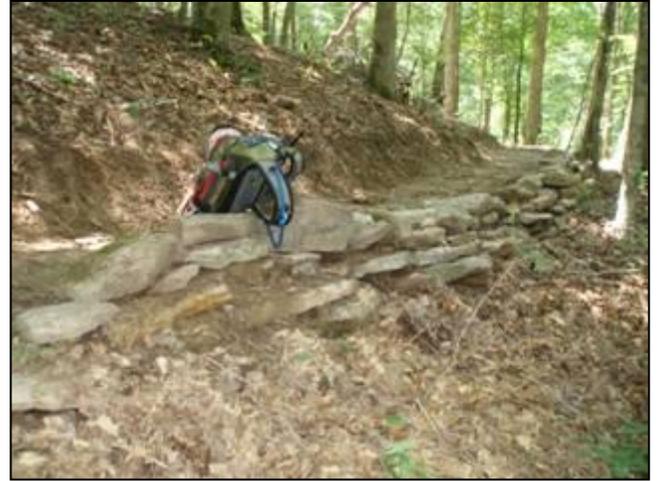
Figure 18. Cribbed trail section along the River-To-River Trail.

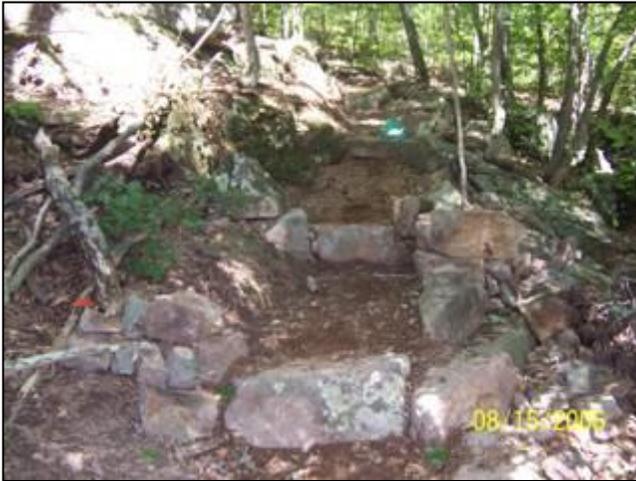
Figure 19. Stone stair case at Secret Canyon.

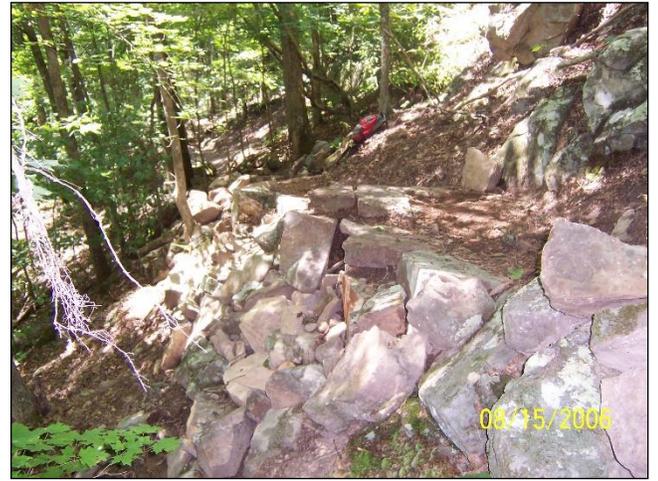
Figure 20. Cribbed trail section at Secret Canyon.

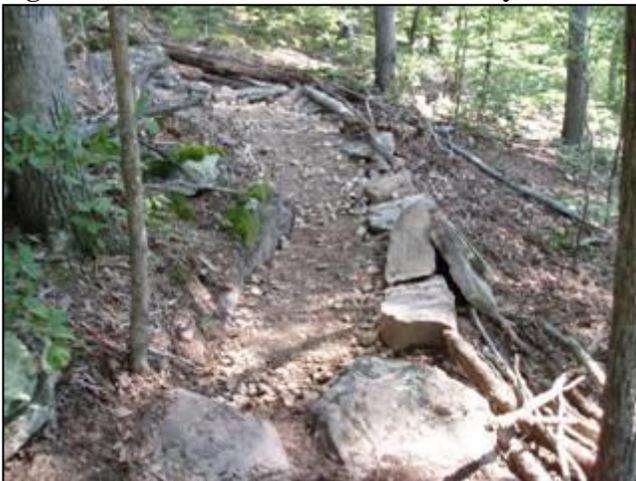
Figure 21. A switchback, with French drain, required two tons of gravel crushed with a sledge hammer.

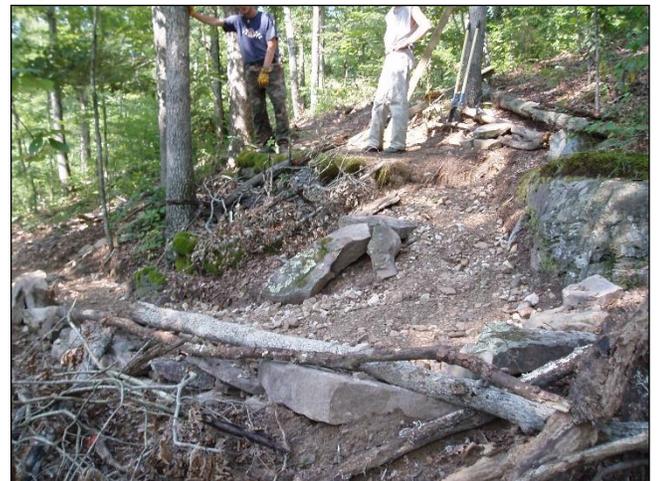
Figure 22. Switchback on Goat Trail above Bowed Tree Creek Crossing.

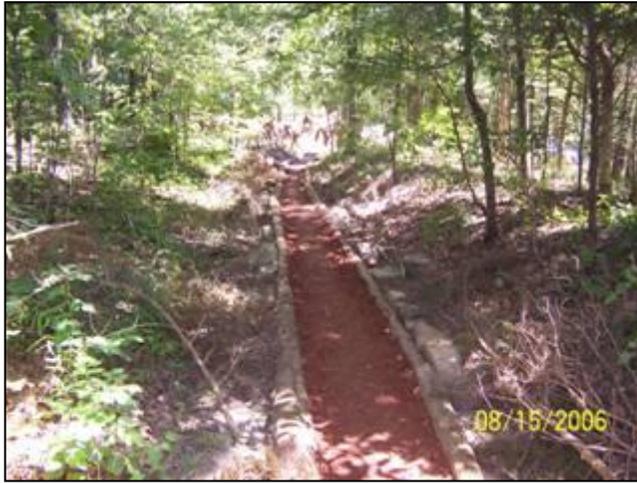
Figure 23. Turnpikes built using cedar logs and filled with gravel and clay mixture raised the trail tread above wet areas.

Native building materials such as cedar trees were also used in the construction of trail features such as turnpikes. The turnpikes were built using cedar logs and filled with gravel and clay mixture that raised the trail tread above wet areas such as perched water tables (Figures 23 and 24).

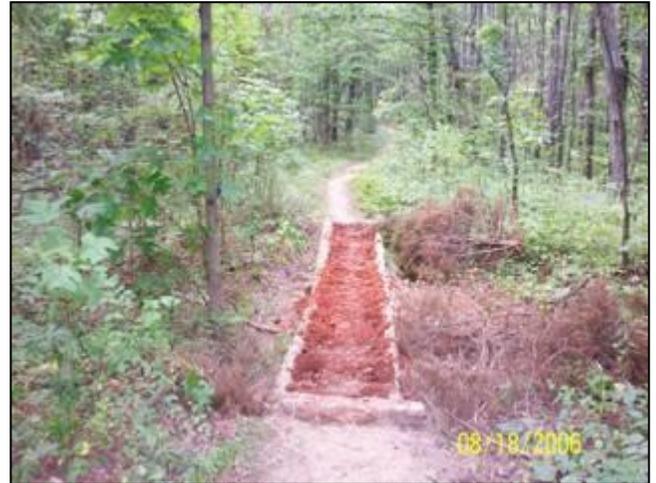
Figure 24. Newly constructed turnpike on trail section 429A north of Secret Canyon.

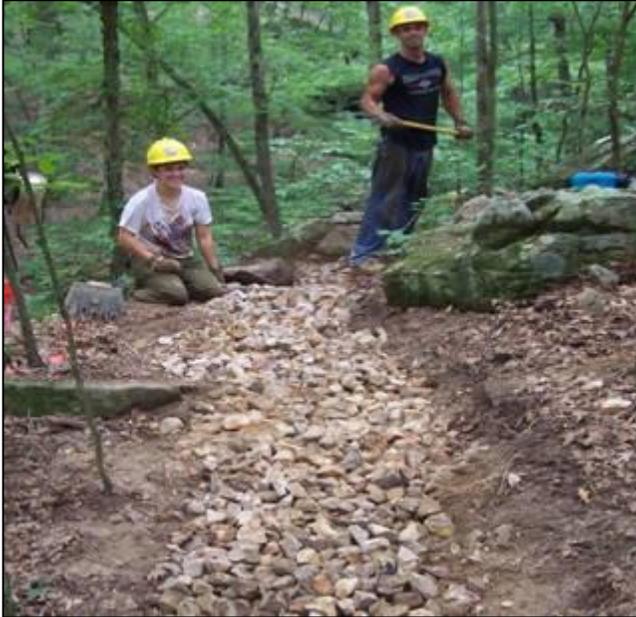
Figure 27. Sandstone being crushed by hand and laid in the trail tread.

Surfacing: When necessary, the trail tread was built up to create sustainable drainage. Sandstone was crushed by hand, laid in the trail tread, and river gravel from nearby dry streambeds was then shoveled into five gallon buckets and carried to the trail to cap the tread (Figures 27 and 28).

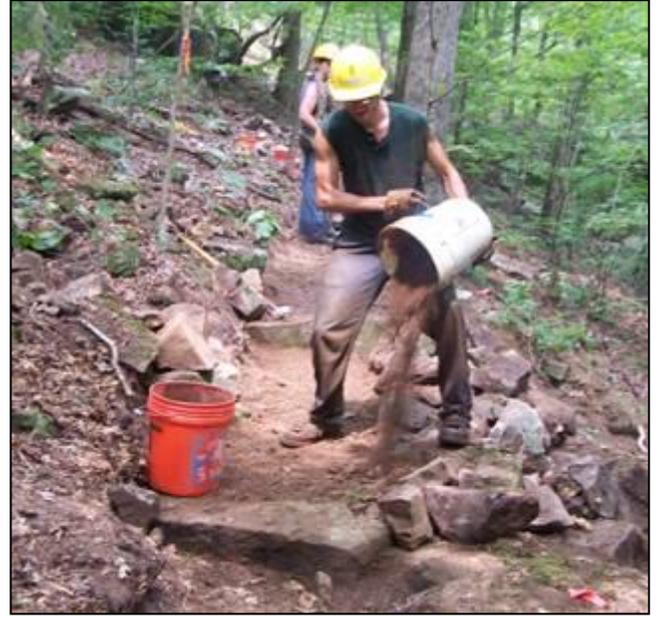
Figure 28. River gravel carried to the trail to cap the tread.

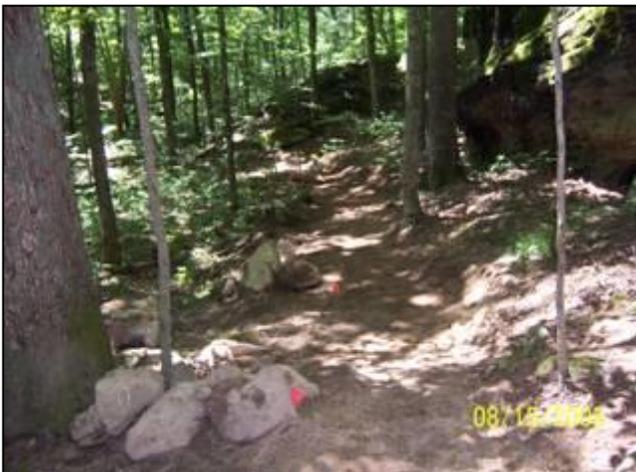
Figure 29. Sandstone placed around base of tree to protect the roots from compaction.

Attention to Detail: Stones were placed around the base of trees along the trail to protect roots from stock animal's hoofs (Figure 29). Stone was also used to harden small seasonal stream crossings (Figure 30).

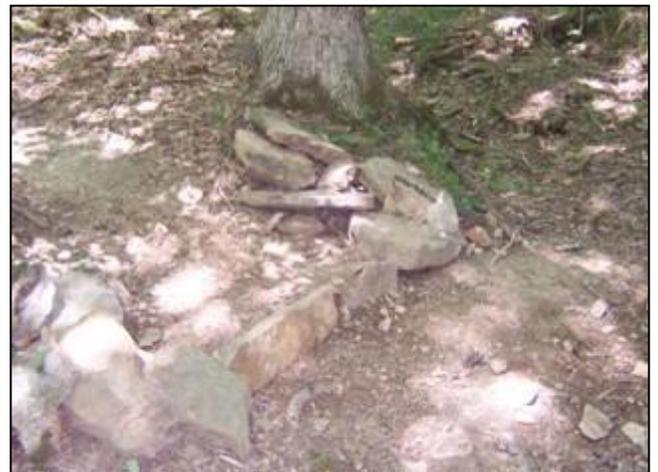
Figure 30. Sandstone used to shore up stream embankments.

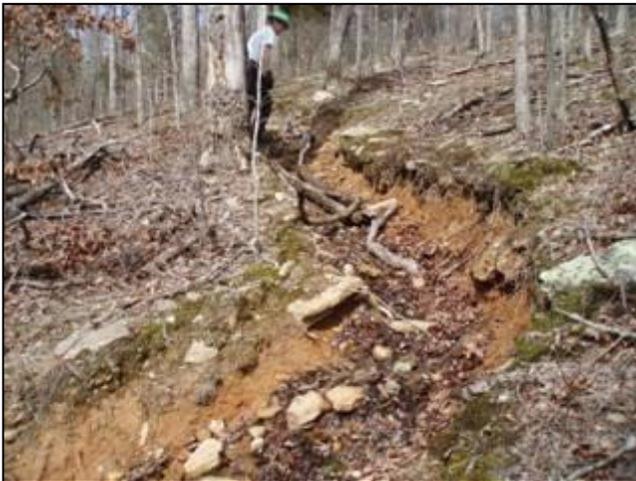
Figure 33. Before. Deeply eroded non-designated section of Goat Trail falling straight down the canyon. This section was brushed in.

Accomplishments: From June – August 2006, the trail crew constructed 4 miles of full-bench trail re-routes in the Lusk Creek Wilderness to include moving nearly 330 tons of gravel and sandstone using only pack animals and hand tools (Figures 31 and 32). Trail features constructed include one major creek crossing, a switchback with French drain, a stone stair case descending hundreds of feet into a canyon, and several hundred linear feet of cribbed retaining walls and turnpikes. By creating connections between designated trails with short re-routes, hundreds of linear feet of eroded non-designated trail were brushed in to allow the process of natural vegetation re-establishment (Figures 33 – 40).

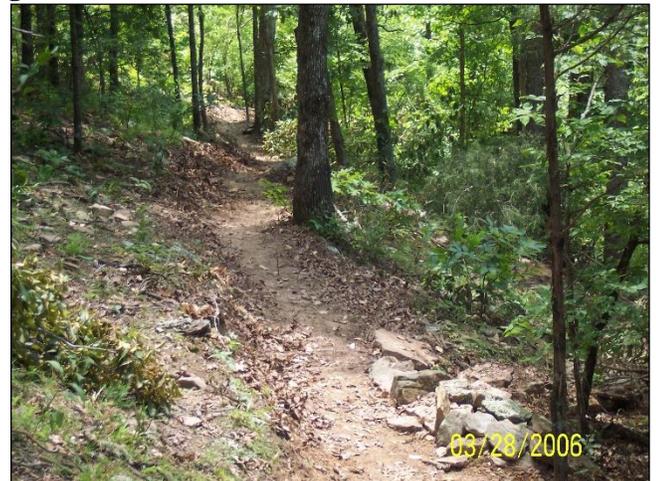
Figure 34. After. Newly re-routed section of Goat Trail following the natural contour and proper grade.

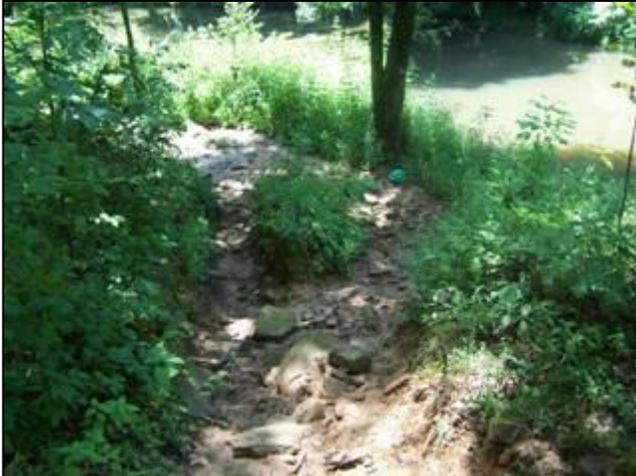
Figure 35. Before. Old, eroded non-designated section of River-To-River Trail along Lusk Creek has potential for adding sedimentation to creek.

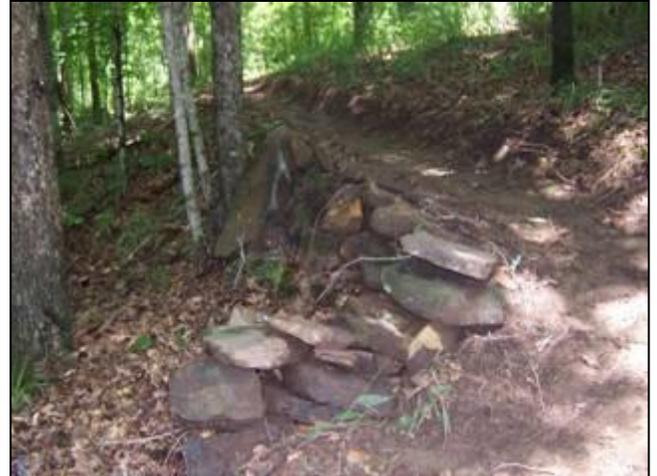
Figure 36. After. Properly located re-route well above the creek and constructed at proper grade eliminating possible sedimentation.

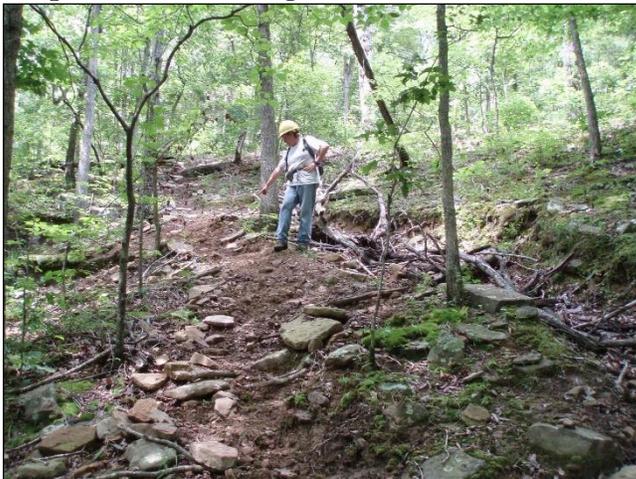
Figure 37. Before. Highly eroded non-designated section of Goat Trail west of Bowed Tree Crossing.

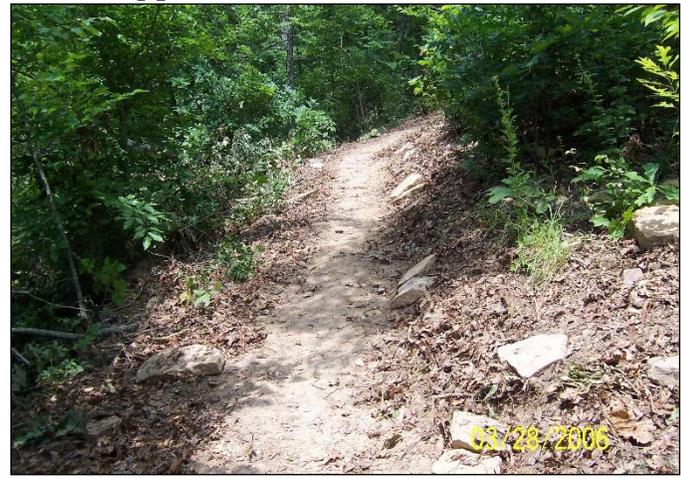
Figure 38. After. New section of Goat Trail re-route that eliminated non-designated eroded section.

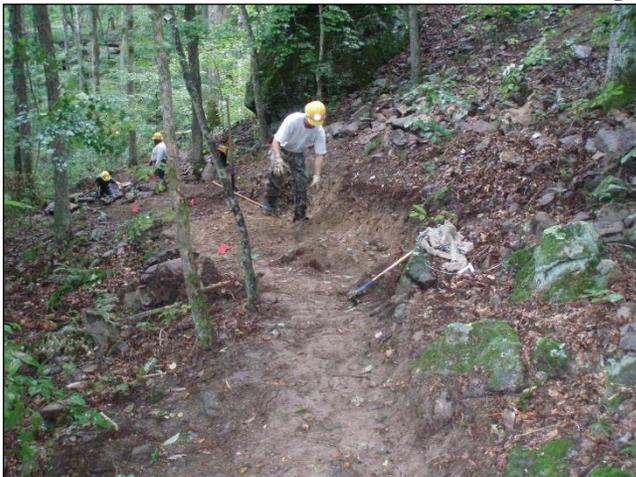
Figure 39. Before. Trail section climbing up north out of Secret Canyon with steep slope.

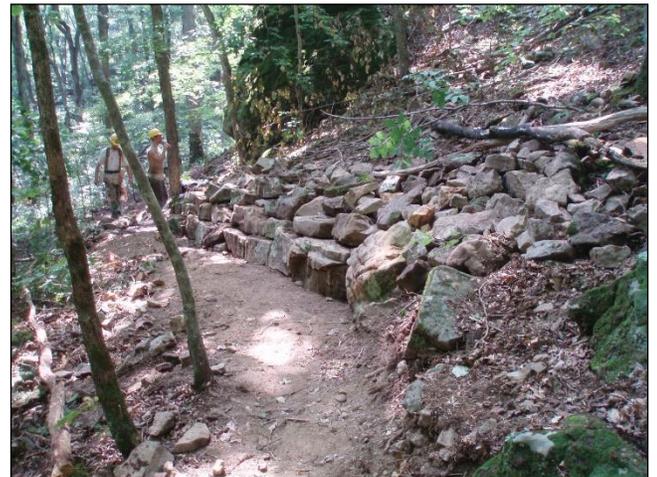
Figure 40. After. Cribbed retaining wall built in order to implement sustainable trail on steep side slope.

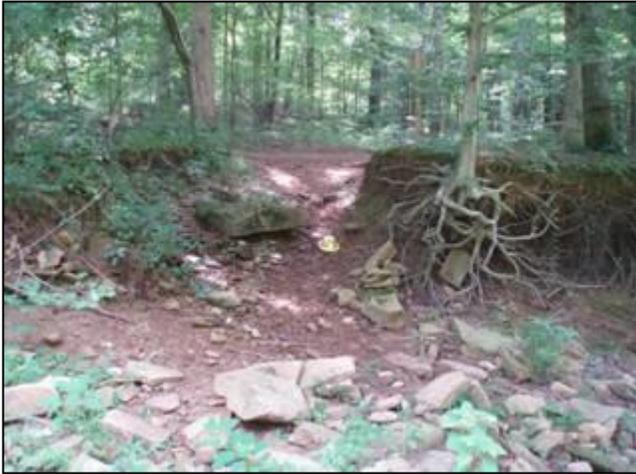
Figure 41. Before. Deeply eroded site of old crossing (north embankment) - dangerous and added sedimentation to Lusk Creek.

Accomplishments (Blanchard Church Creek Crossing): The Blanchard Church Creek Crossing was relocated and constructed to mitigate resource damage and provide improved recreation opportunities. The old crossing was deeply eroded, dangerous to use, and had the potential to add sedimentation to Lusk Creek (Figure 41). Once the new crossing was build, the old crossing was brushed in with limbs and sandstone (Figure 42). The new Blanchard Church Creek Crossing required the use of horse and mule teams provided by local residents. The teams hauled 21 tons of gravel and 18 cedar logs into the wilderness necessary to build the many steps of the new crossing (Figures 43 - 46).

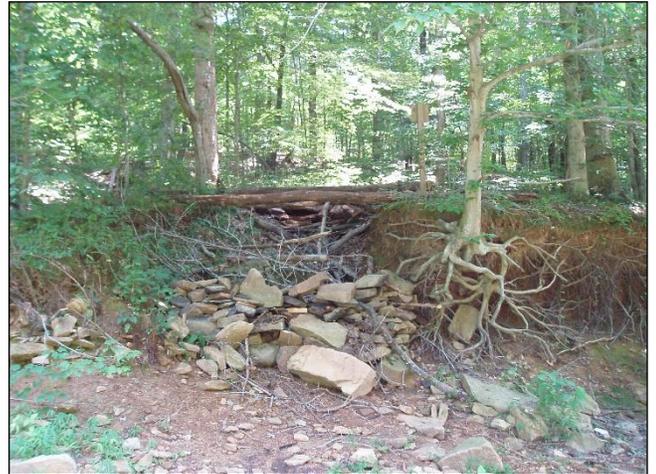
Figure 42. After. North embankment of old crossing after being brushed in.

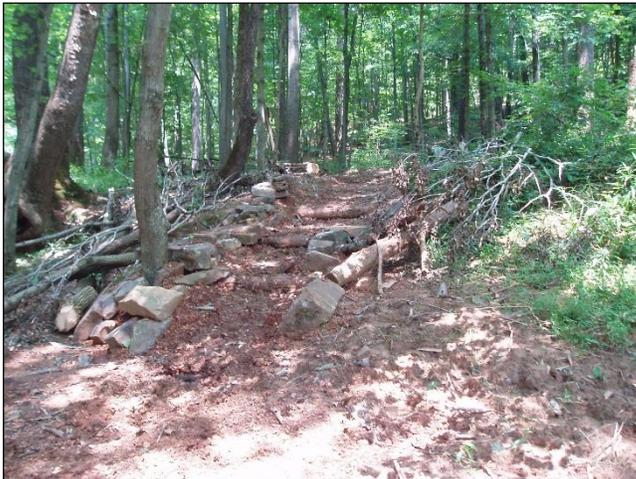
Figure 43. After. Newly reconstructed north embankment of Blanchard Church Creek Crossing.

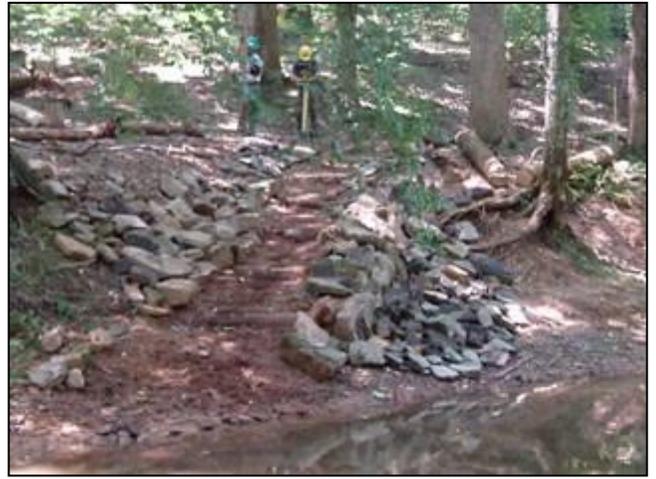
Figure 44. After. Newly reconstructed south embankment of Blanchard Church Creek Crossing.

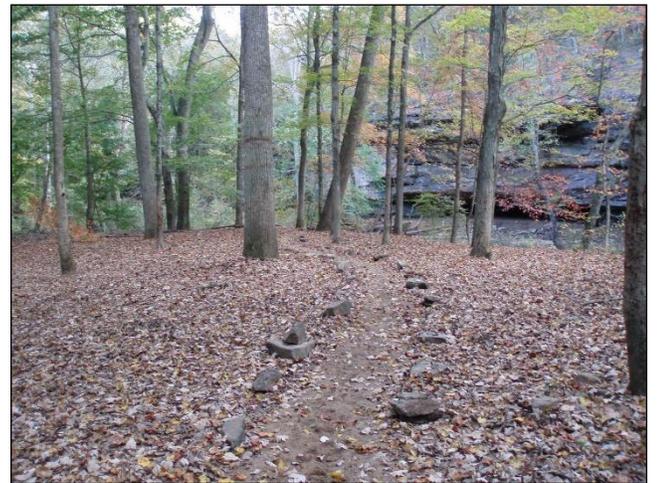
Figure 48. Saltpeter Cave tie-up area, after highline was relocated and previous confinement area converted to ride-through-only.

Accomplishments (Trail Maintenance): In addition to the construction of new trails, heavy maintenance was conducted on twenty miles of trail to clear 55 fallen trees, build 70 erosion control features such as drainages and water bars, reinforced 80 feet of stream bank with stone, and closed nearly 500 linear feet of braided trail (Figures 47 and 48).

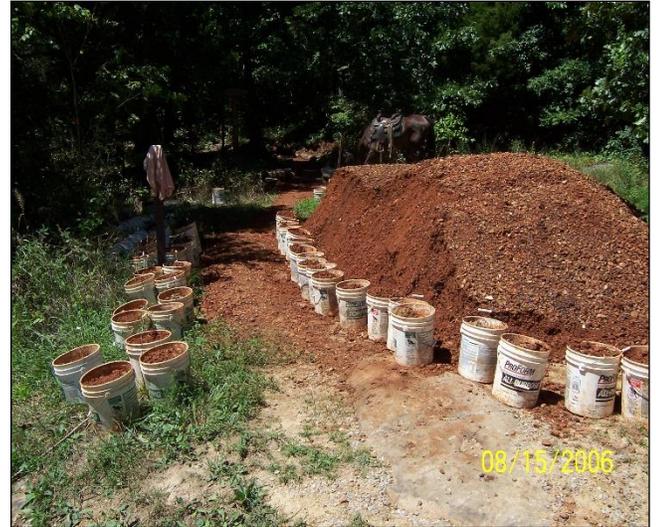
Figure 50. Red fines gravel pile just outside the wilderness.

Accomplishments (Pack Stock Team): Also, contracted pack stock teams hauled an additional 240 tons of gravel into the wilderness to harden 5.25 miles of trail tread and provide gravel for the construction of major trail features (Figure 49). The type of gravel used in the wilderness is commonly referred to as red fines gravel and has a clay binder (Figure 50). The clay binder allows the gravel to stick together and harden to a consistency of that of concrete while creating a natural appearance when used within the wilderness. Each finished trail section had a gravel depth of at least four inches and a width of twenty inches. The placement of gravel on the trails in the designated areas improved drainage, especially during wet weather conditions, and provides a safer surface for trail users.

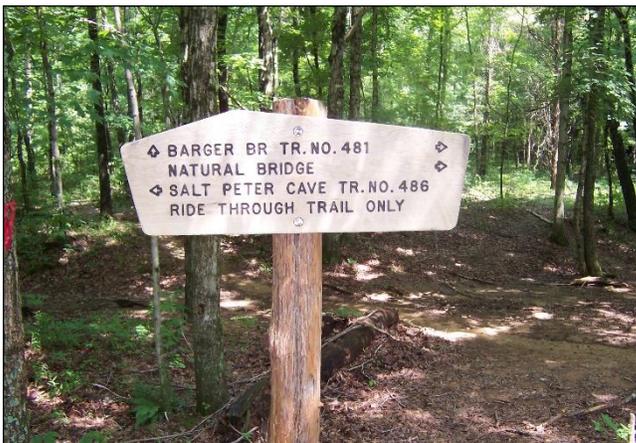
Figure 51. New wilderness directional trail sign installed in the Lusk Creek Wilderness.

Accomplishments (Trails Sign Plan): During the summer of 2006, the first phase of the trails sign plan was implemented in accordance with the Trails Designation Project. A total of 50 new wilderness directional trail signs were installed throughout the Lusk Creek, Bay Creek and Garden of the Gods Wilderness Areas. The signs were installed along designated trails located at trail junctions, entrances to wildernesses, and authorized equestrian crossings of Lusk Creek. The signs were mounted on round, peeled-full-length cedar posts to fit into the wilderness character (Figure 51). Vandal resistant lag screws were used to attach the signs to the posts.

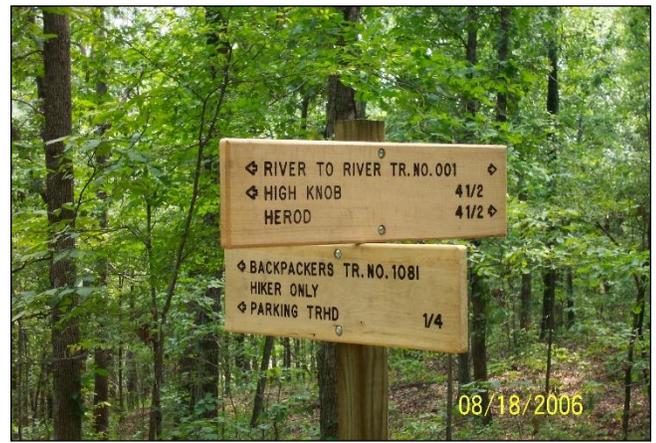
Figure 52. New directional trail signs installed along designated trails, outside of the wildernesses.

In addition to the 50 signs in wildernesses, 173 new directional trail signs were installed along designated trails, outside of the wildernesses, within the Lusk Creek, Eagle Creek, Big Grand Pierre Creek and Upper Bay Creek watersheds. The directional signs are mounted on a full length pressure treated posts using the vandal resistant lag screws (Figure 52). The second phase of the signage project of the Trails Designation Project is scheduled for completion by October 2007.
